Valve damage and causes

TRW

EngineComponents

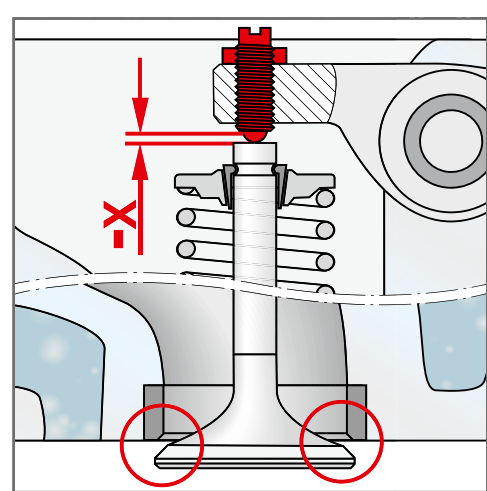
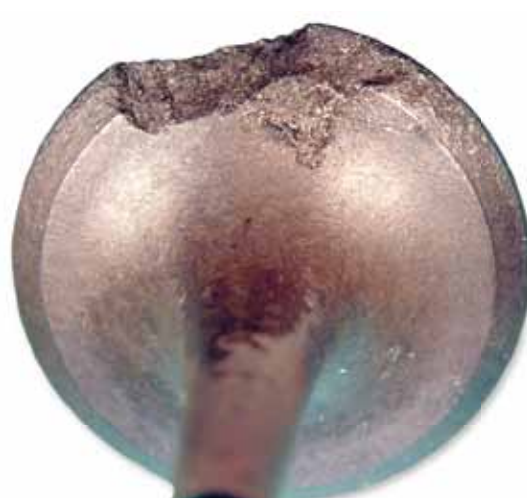
Incorrect Valve Clearance Settings

Cause:
The valve clearance is set too tight or the maintenance intervals are exceeded.

Result:
The valve no longer closes properly. Combustion gases flow past the valve seat and heat up the valve head. This causes the valve head to overheat and burn through in the area of the seat.

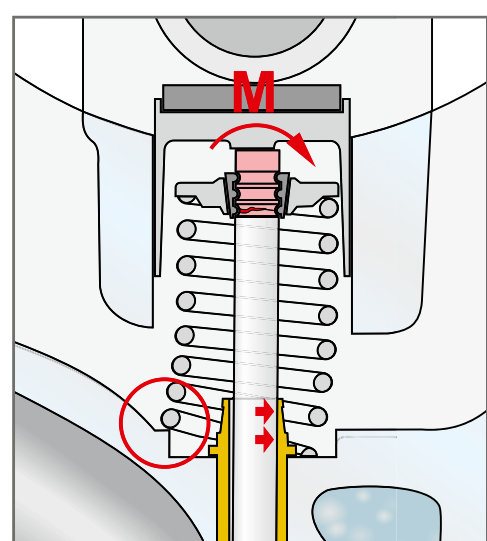
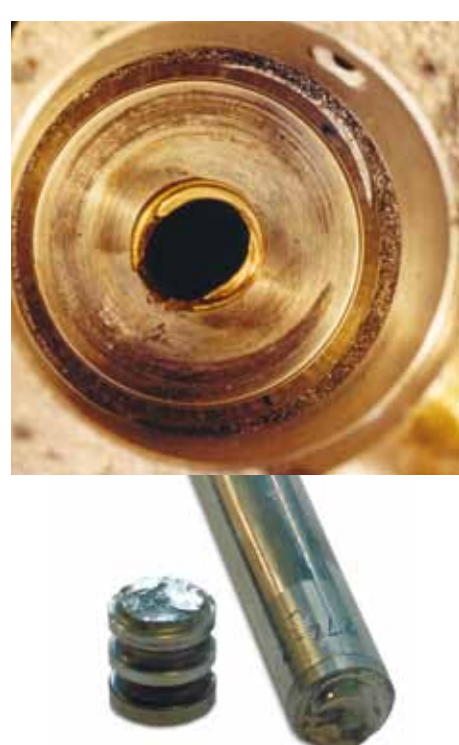
Error during Installation of the Valve Springs

Cause:
The spring was not inserted correctly during installation. The tilted spring had induced a lateral bending moment (M) on the valve stem.

Result:
The direction of the resulting bending load changed alternately from one side to another, caused a fracture of the end of the valve stem and destroyed the valve guide.

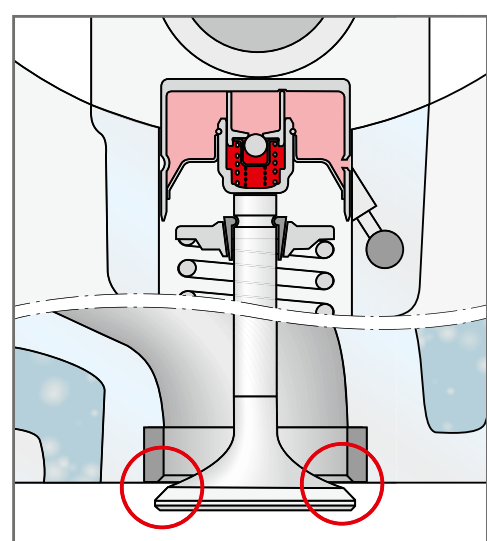
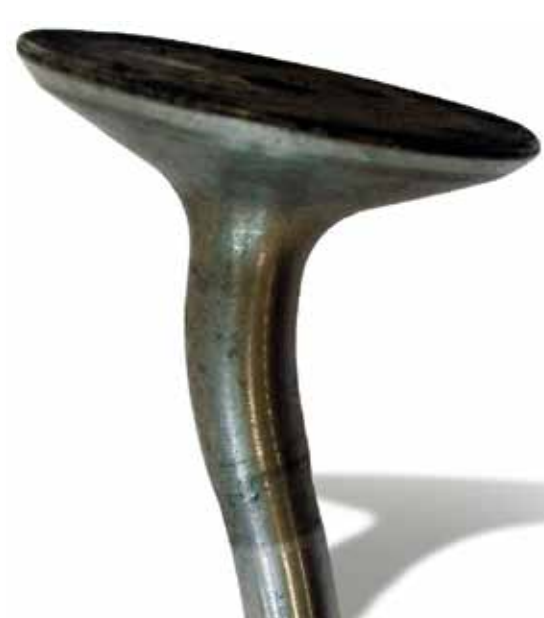
Error during Installation of the Hydraulic Tappets

Cause:
After installation of the tappets, the minimum required waiting time before starting the engine (at least 30 minutes) was not observed. As a result, the excess oil in the working chamber of the tappets did not have enough time to escape.

Result:
If the engine is started prematurely the valves strike against the piston and can bend or break.

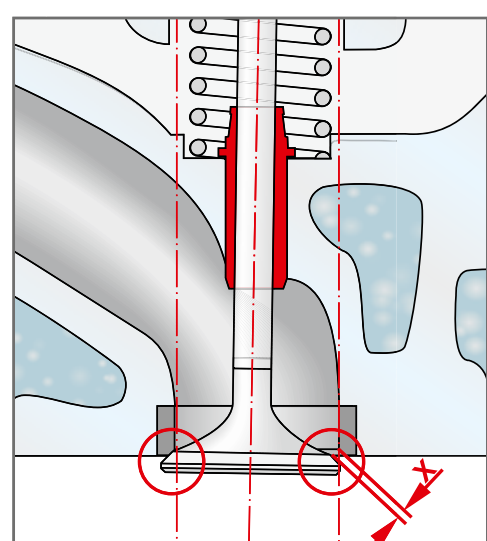
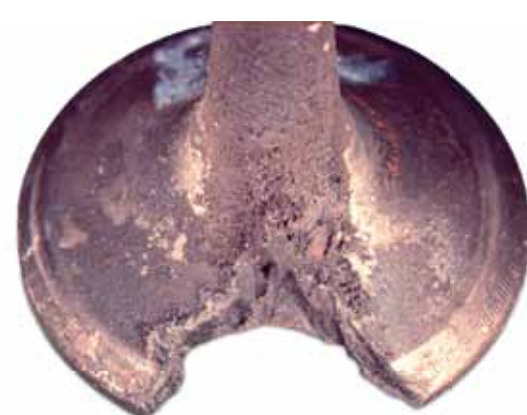
Alignment Error on the Valve Seat Insert or Valve Guide

Cause:
Non-centric remachining of the valve seat or guide.

Result:
The valve fails to close properly, overheats and burns through in the area of the seat. Fatigue fractures in the area of the recess may also occur as a result of the unilateral loading of the valve head.

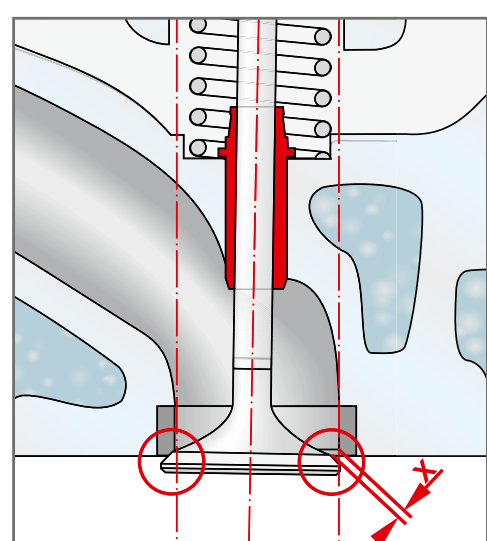
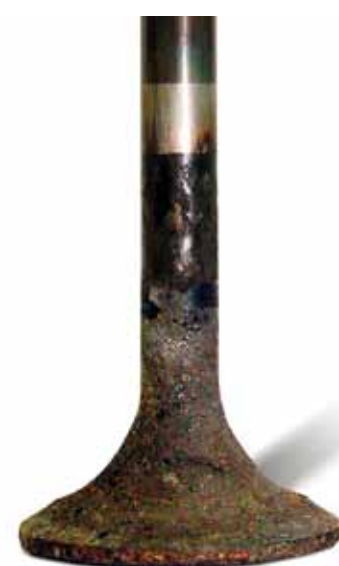
Excessive Valve Guide Clearance

Cause:
The valve guide clearance is too large due to excessive wear of the valve guides or due to excessive reaming during reconditioning.

Result:
The influence of hot gases can cause significant heat induction in the valve guide. The valve becomes stiff and fails to close properly, with overheating of the seating surface occurring as a result (material is burned or melted off).

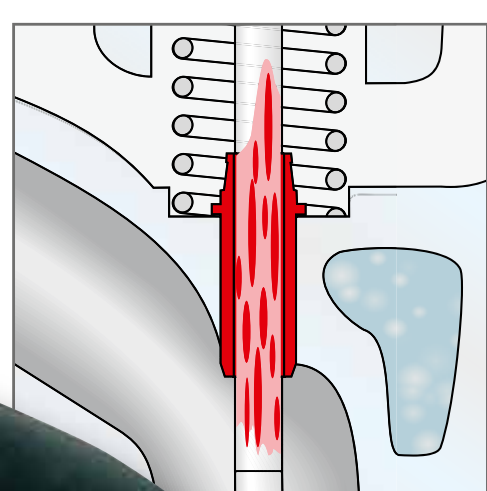
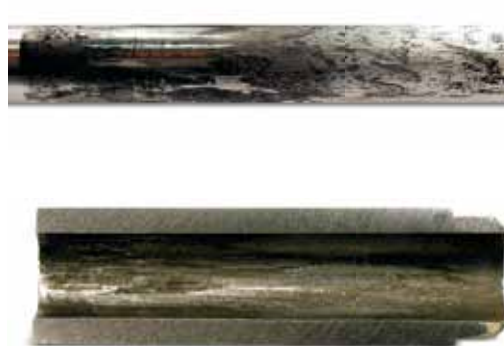
Insufficient Valve Guide Clearance

Cause:
The guide diameter was dimensioned too small during replacement of the valve guides.

Result:
Stiffness and seizures between valve stem and valve guide. Consequential damage such as overheating of the disk or seat area can occur.

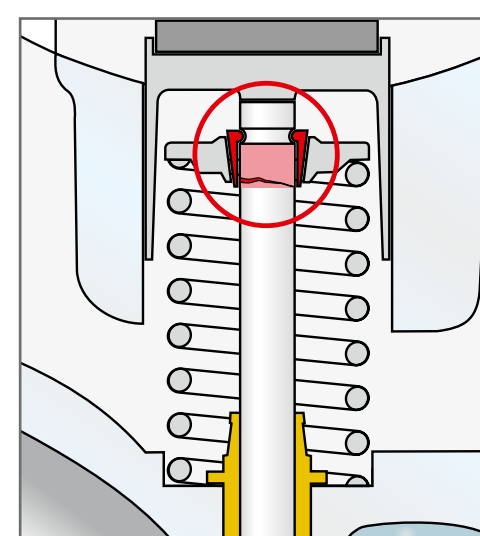
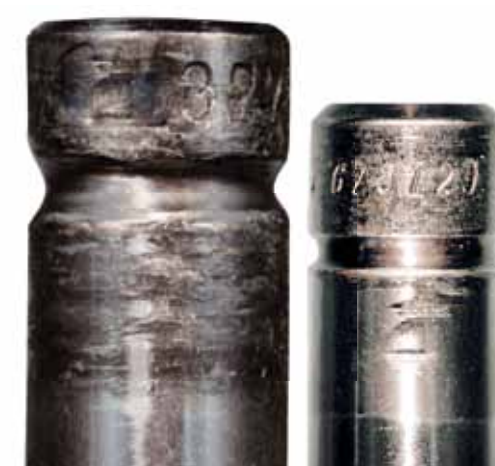
Use of Worn Valve Cotters

Cause:
Old, worn valve cotters were used during replacement of the valves.

Result:
If worn valve cotters are reused the clamp fitting can become loose during operation. This results in frictional corrosion on the stem and weakening of the valve in this area. This can cause vibration failure and a breakage of the valve stem.

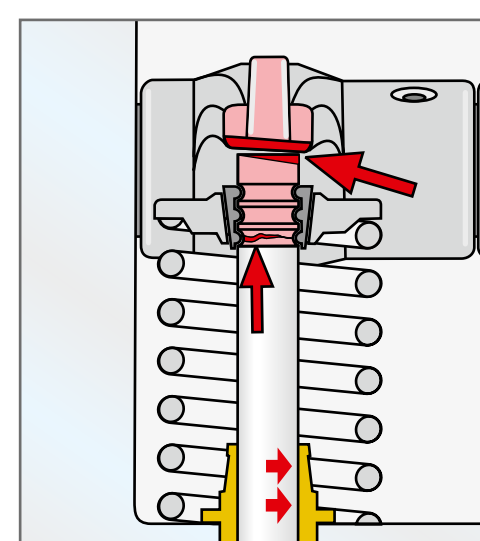
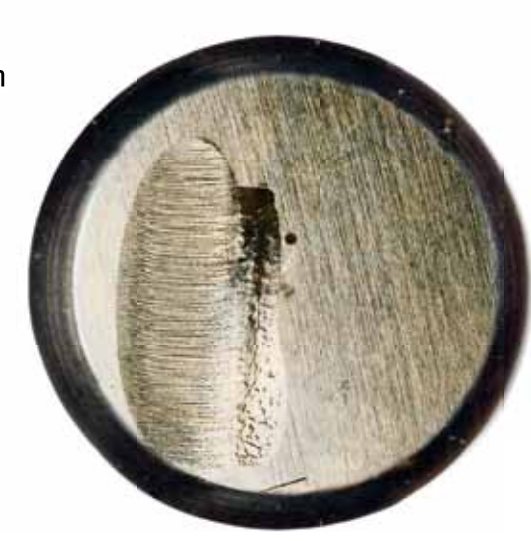
Installation of Damaged Rocker Arms or Cam Followers

Cause:
Forces are directed eccentrically from the rocker arm to the end face of the valve stem.

Result:
One-sided wear occurs on the stem and the end face of the stem. The lateral forces induced on the valve stem by the eccentric load transfer cause fatigue fractures in the area of the clamp fitting.

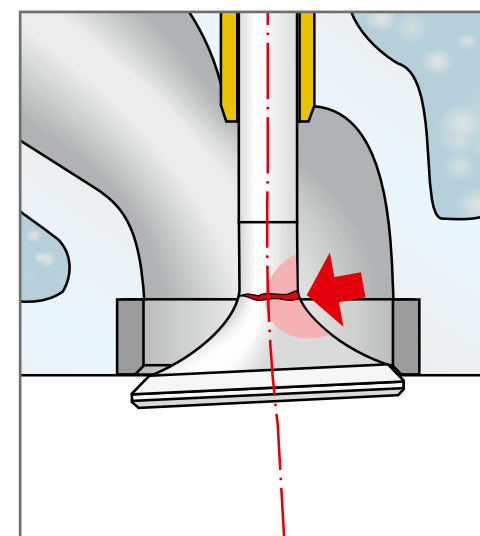
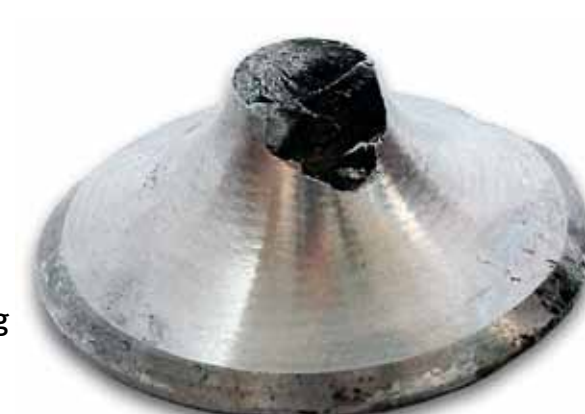
Installation of Bent Valves

Cause:
A bent valve stem will cause overhang seating of the valve head on the valve seat insert.

Result:
The unilateral load causes the direction of the resulting bending load to change alternately from one side to another, causing fatigue fractures in the valve chamfer at the transition to the shaft or valve head.

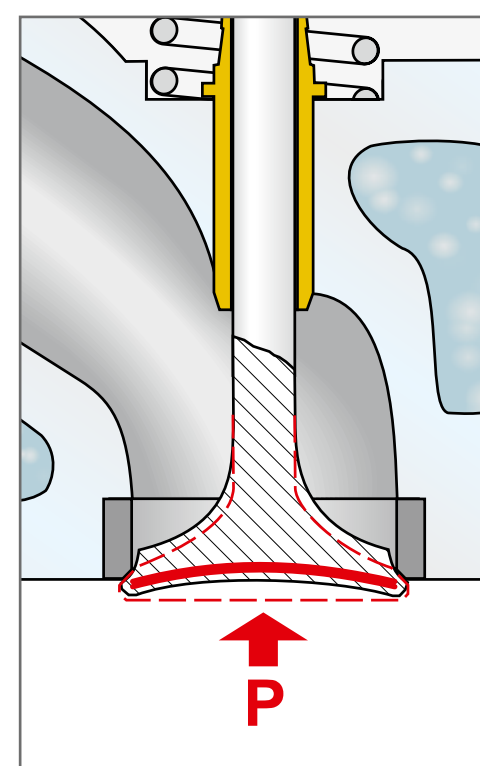
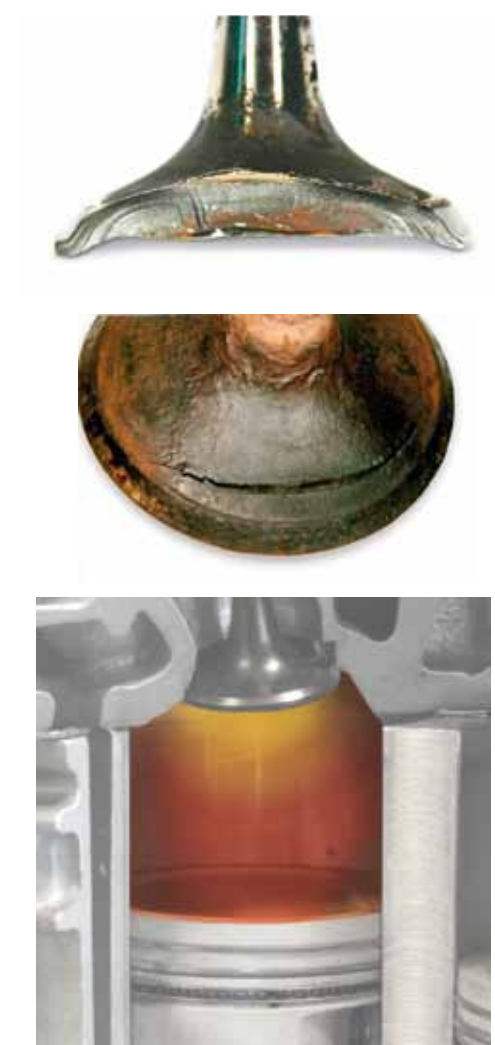
Valve Overloading Due to Abnormal Combustion

Cause:
Significantly increased pressure and temperature loads occur in the combustion chamber as a result of abnormal combustion.

Result:
The valve head can no longer withstand the high thermal and mechanical loads and bends inwards. This results in the valve head being deformed into a so-called tulip shape and causes fractures in the area of the valve head.
