Piston Damage and causes

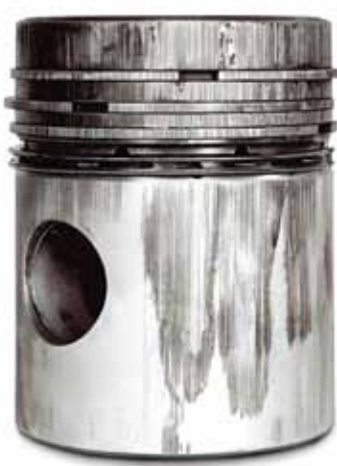
Seizure due to overheating (mainly piston crown)

- Overheating due to abnormal combustion
- Bent/blocked oil splash jet
- Installation of incorrect pistons
- Faults in the engine cooling system
- Restriction of clearances in the upper running surface

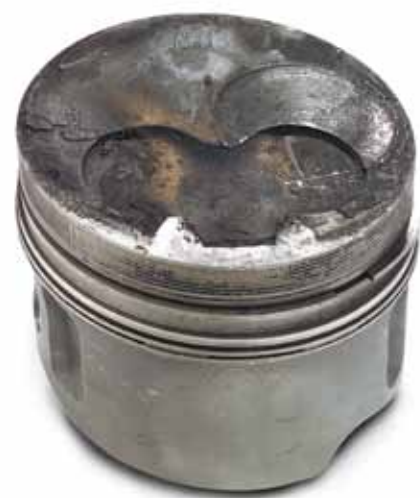
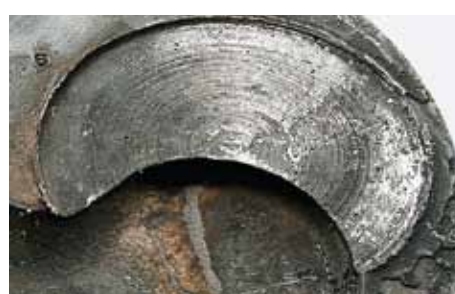
Impact marks

- Excessive piston protrusion
- Excessive reworking of the cylinder-head mating face
- Incorrect valve recess
- Incorrect cylinder head gasket
- Oil carbon deposits on the piston crown
- Insufficient valve clearance

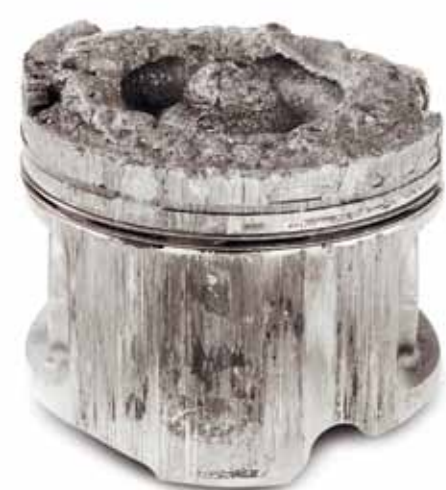
Fused/melted off material

- Faulty injectors
- Incorrect quantity of injected fuel
- Incorrect injection timing
- Insufficient compression
- Ignition delay
- Oscillations in the fuel-injection lines

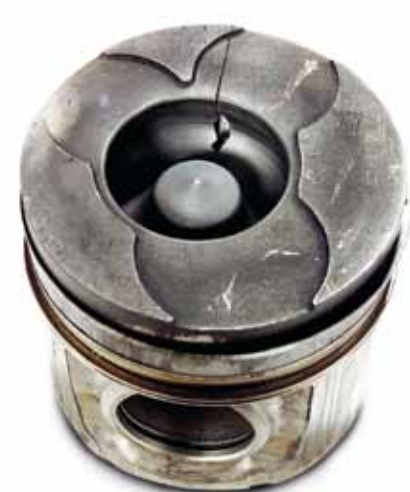
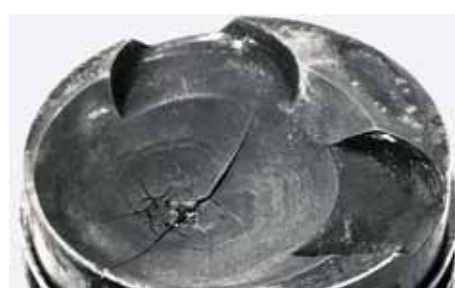
Cracks in the piston crown and combustion bowl

- Faulty or incorrect injector
- Incorrect injection timing
- Incorrect quantity of injected fuel
- Insufficient compression
- Deficient piston cooling
- Installation of pistons with incorrectly shaped piston recess
- Performance enhancement (e.g. chip tuning)

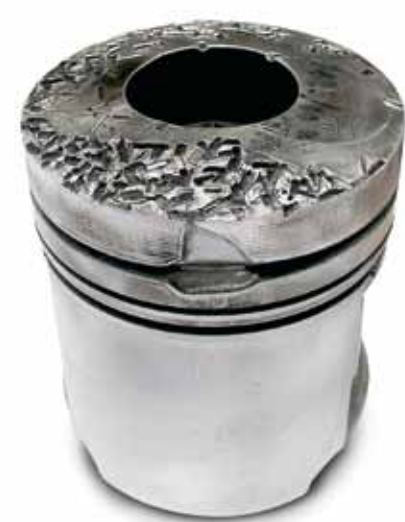
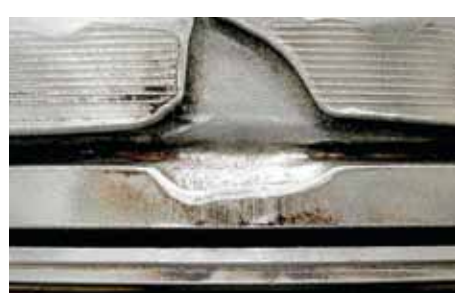
Material washout in the ring zone

- Incorrectly installed piston rings
- Fuel flooding
- Severe axial wear of piston ring grooves and piston rings
- Piston ring flutter

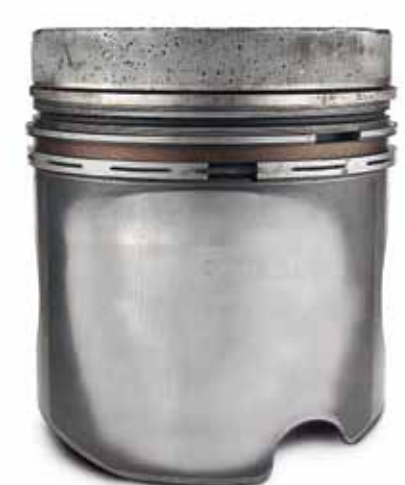
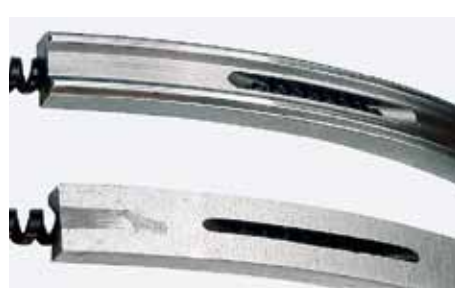
Radial wear due to fuel flooding

- Faults during the mixing stage
- Abnormal combustion
- Insufficient compression pressure
- Incorrect piston protrusion

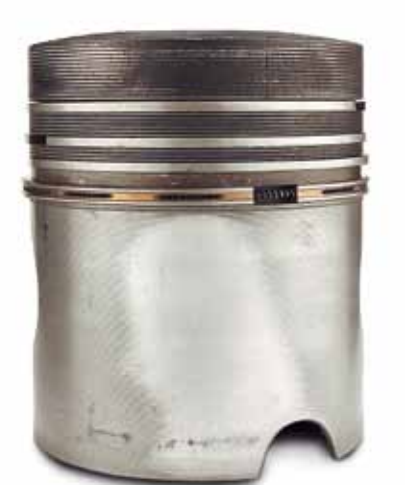
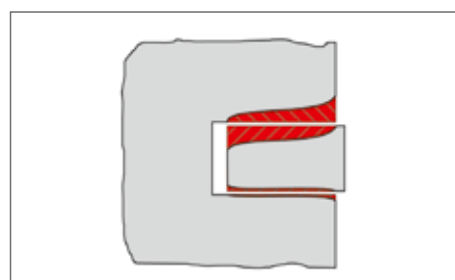
Axial wear due to ingress of dirt

- Abrasive dirt particles due to inadequate filtration
- Particles of dirt which are not completely removed during an engine overhaul (swarf, blasting material)
- Abraded particles caused when the engine is being run in

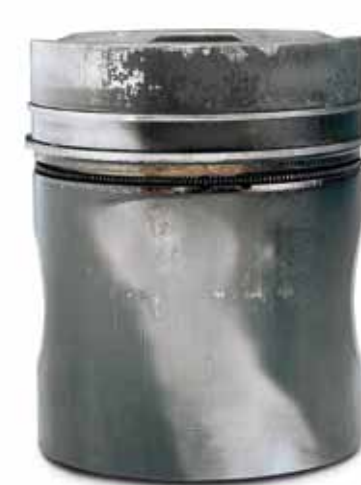
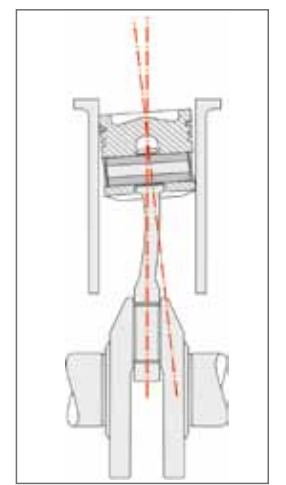
Asymmetric wear pattern of the piston

- Twisted/bent connecting rod
- Connecting rod small end bored at an oblique angle
- Cylinder bores not straight
- Individual cylinders not installed straight
- Excessive connecting rod bearing clearance

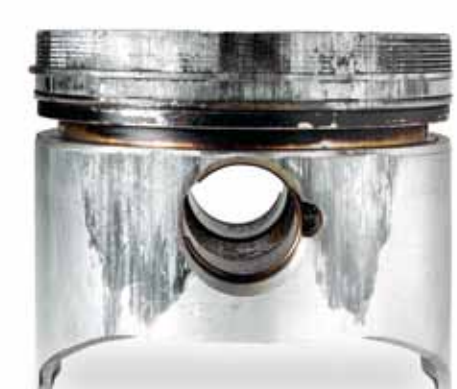
45° seizure

- Excessively narrow fit of the piston pin
- Seizure in the connecting rod small end (insufficient lubrication when the engine was first taken into operation)
- Incorrectly installed shrink-fit-connecting rod
- Excessive load on the engine before it reaches operating temperature

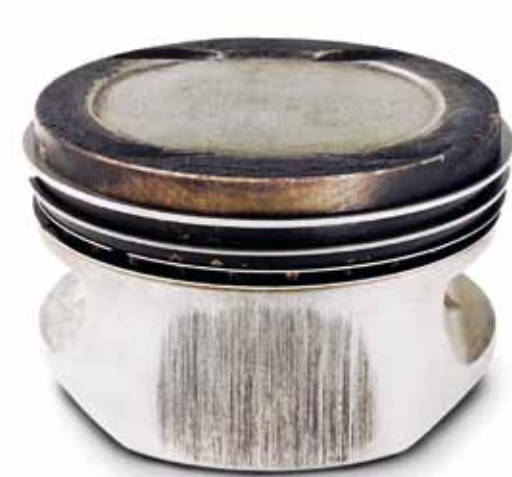
Dry-running damage

- Over-rich operation
- Abnormal combustion (misfiring) insufficient compression
- Defective cold-starting device
- Oil dilution with fuel

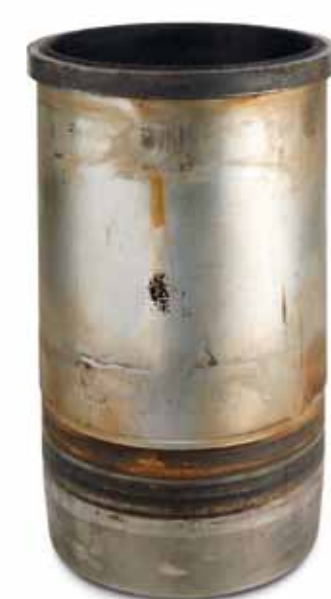
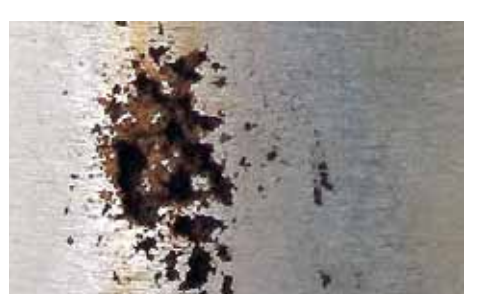
Cavitation

- Poor or inaccurate seating of the liner
- Use of incorrect O-rings
- Use of unsuitable coolants
- Insufficient pre-pressure in the cooling system
- Operating temperature too low/too high
- Restricted coolant flow

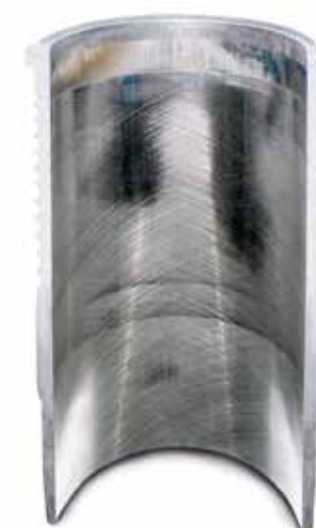
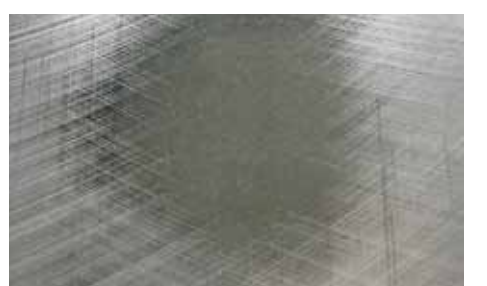
Shiny marks in the upper part of the cylinder

Oil carbon deposits on the piston top land due to:

- Excessive ingress of engine oil into the combustion chamber due to defective parts
- Increased emissions of blow-by gases with oil entering the intake tract
- Insufficient separation of oil mist from the blow-by gases
- Frequent idle or short journey operation
